## **Limited Visual Dam Safety Inspection Summary Report**

**MA-054**

**Horner Reservoir**

**May 2006**

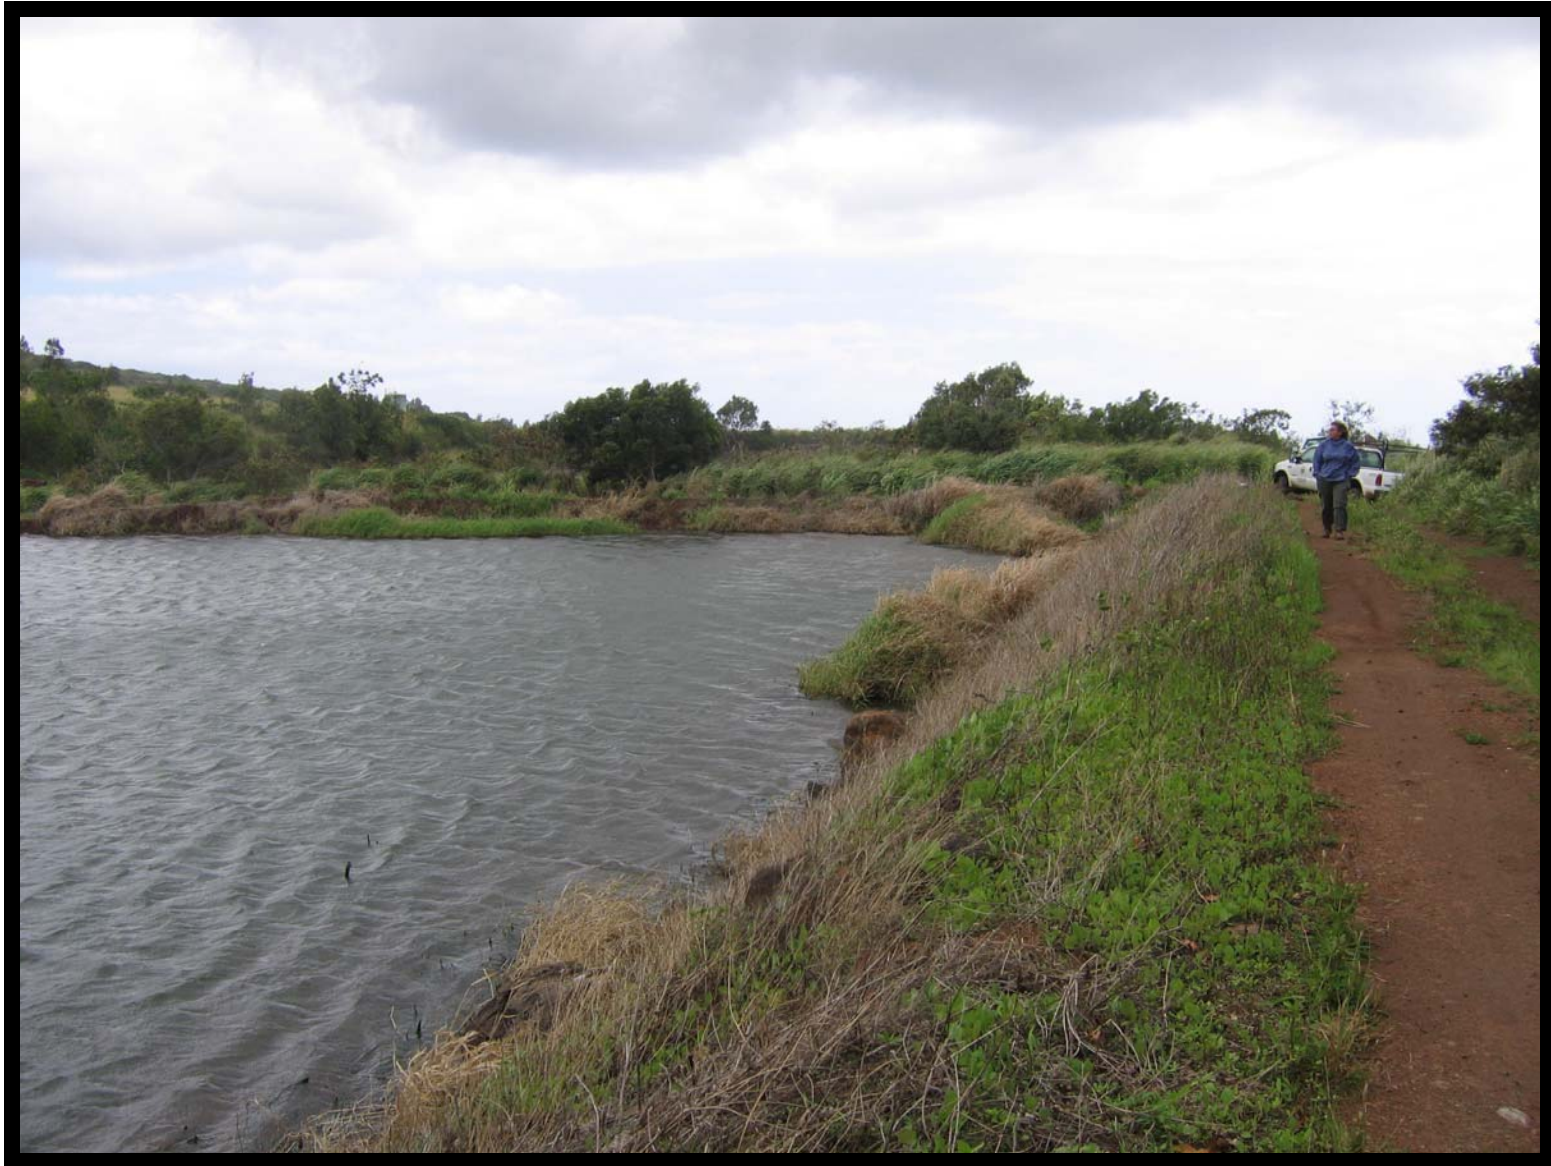
054 View of upslope and crest looking to left end of dam.

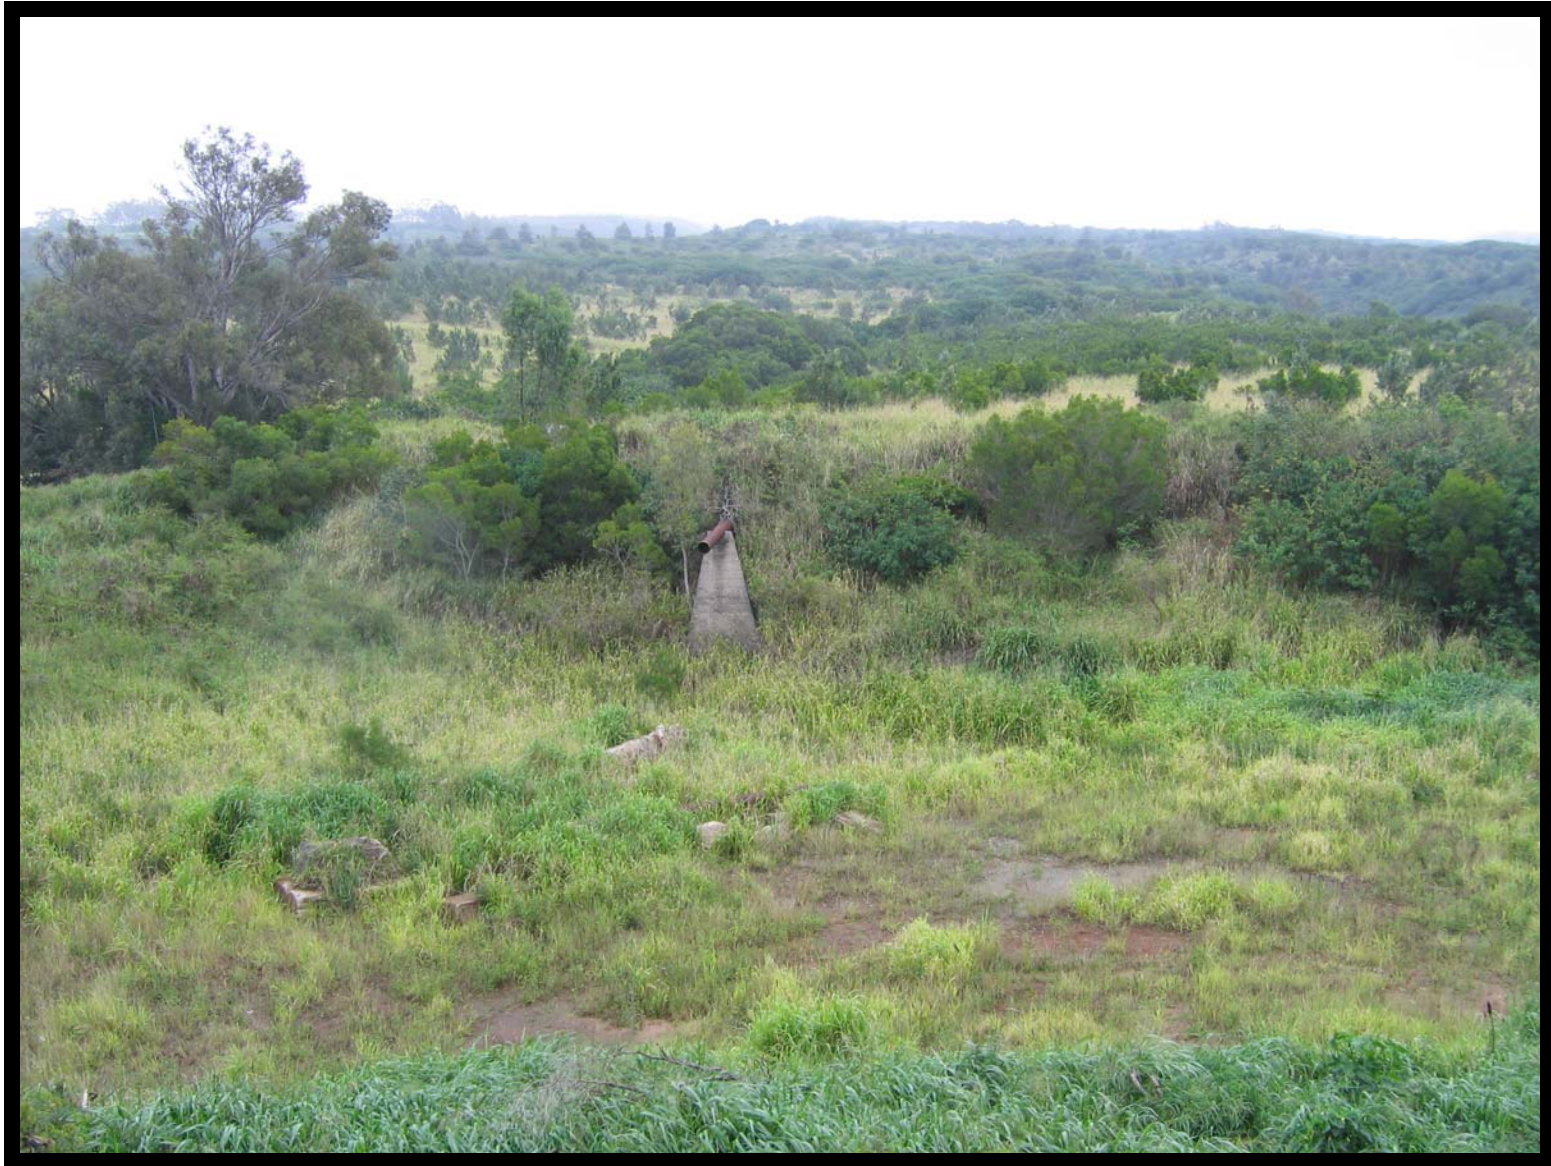
Half of the reservoir was cutoff by a placing berm (with bulldozer) after failure of downstream slope due to conduit piping in 1988. The integrity of the berm appears satisfactory but should be further evaluated.

054 Upstream View of breached half of reservoir no longer in service.
